Department of Water Resources

PILOT LEVEE MAINTENANCE STUDY

[Preview of Bulletin No. 167]

FEBRUARY 1966

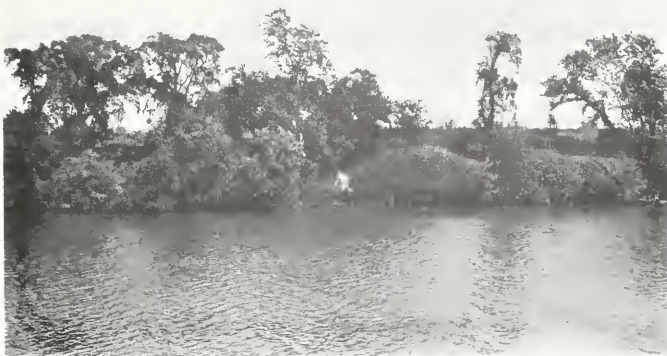
Undisturbed levee section demonstrating
deferred maintenance. Inspection is
practically impossible.

Levees must be inspected to locate rodent burrows, caves, sloughs, or other damages to the structures. Inspection is, of course, essential, and vegetation must not stand in the way of performing this job effectively.

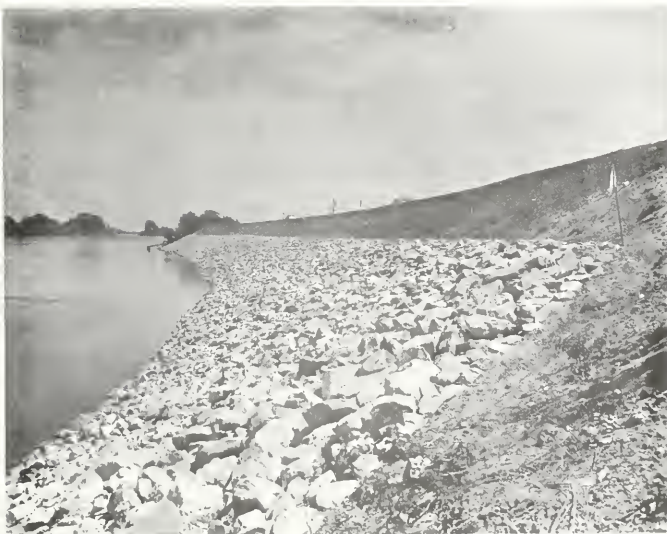
Reconstructed levee revetted with rock.
Flood control consideration only.

existing vegetation, reslope the critical section, and place rock revetment on the waterward slope.

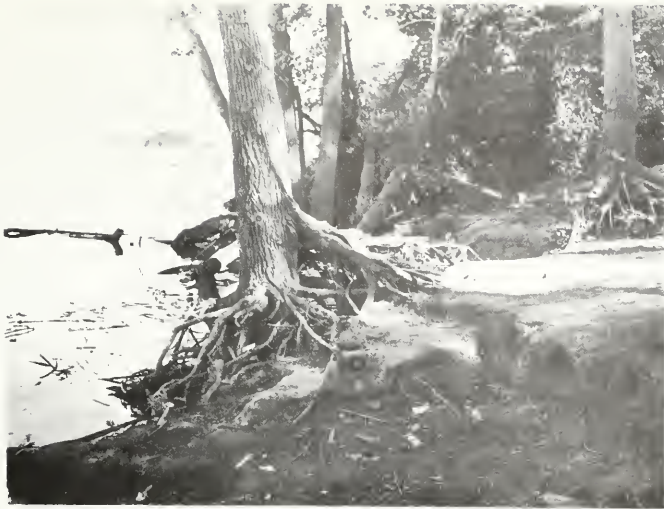
Typical example of erosion around trees
endangering levee stability.

The integrity of the levee can be jeopardized by trees that are in danger of being uprooted by wind or wave action. Fallen trees can also cause adverse current deflections and accumulate drift, both of which compound erosion. In the event of a flood fight, trees can obstruct the placement of canvas, wave wash panels, or sandbags.
